Apple TV 2nd Generation Bottom Cover Replacement

This guide will help you to replace the bottom cover of your Apple TV

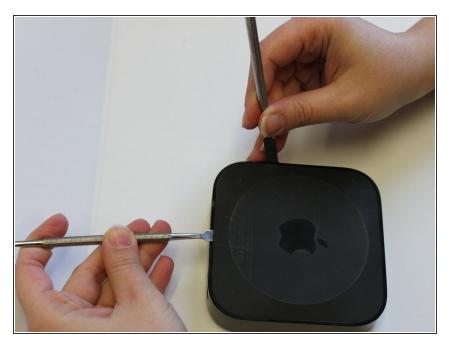
Step 1 — Bottom Cover

As the Apple TV doesn't have any visible screws or points of entry, the first step is to use a couple of metal spudger to carefully loosen and remove the rubber base/bottom cover from the upper case.

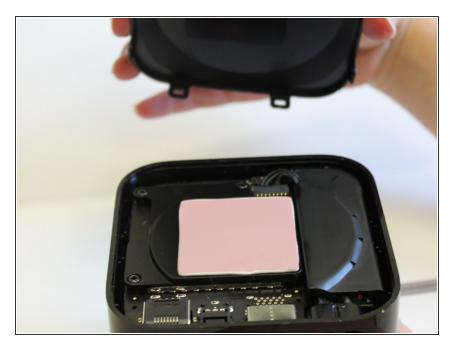
Step 2

Position the replacement base over the exposed interior of the Apple TV.
Gently press the cover down into the Apple TV until the interior tabs snap into place and the base is attached securely to the upper case.
