MacBook Pro 15" Touch Bar 2019 Teardown

Our search for the new 'material' in Apple's 15-inch MacBook Pro's butterfly keyboard unveiled two significant changes. Performed May 22, 2019.

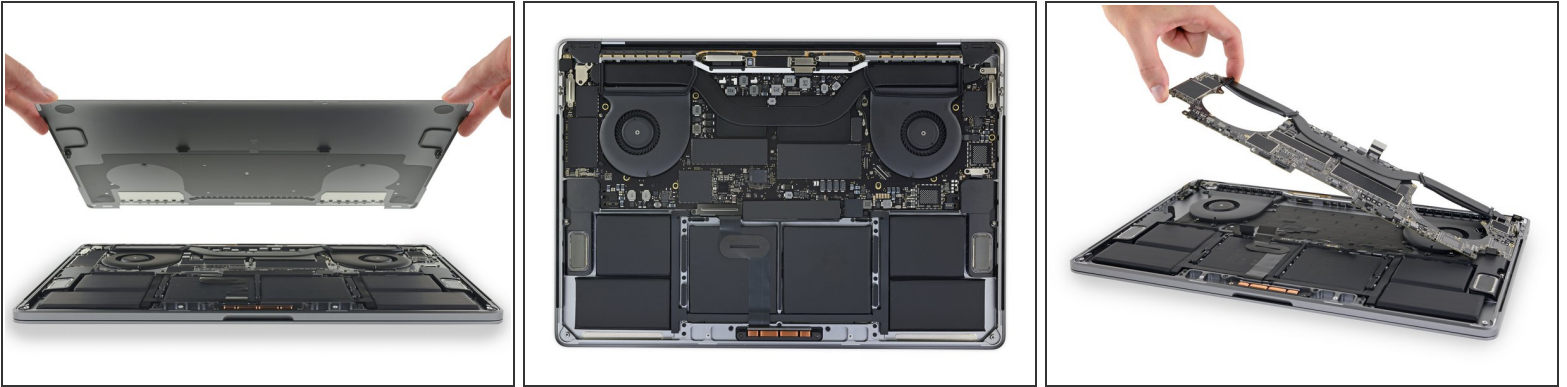
Step 2

- ☑ Last time, we needed two [different teardowns](#) to get to the bottom of one of these laptops—so for once, let's skip the formalities.
- Just like a cooking show, we cut out the nitty and get to the gritty— *voilà!* It's open!
- ① If you *are* curious about how to get inside, it's exactly the same procedure as the 2018 edition ... which we [already have guides for](#)!
- As promised, this is looking *mostly* like a spec bump—the hardware appears visually indistinguishable from last time. Let's pull the board and look closer.

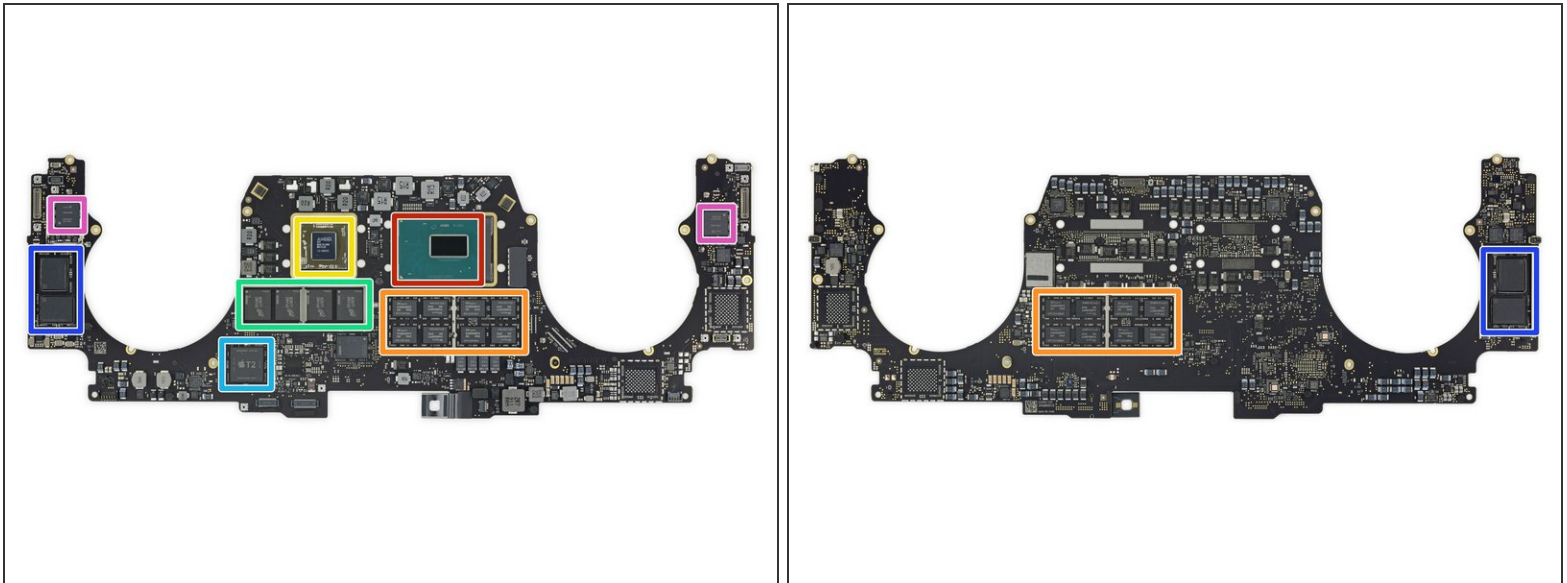
Step 3

- With zero modular components, there's no chance of upgrading any of this hardware. Speak now or forever hold your chips:
 - 9th-generation Intel Core [i7-9750H](#) 6-core processor
 - 16x SK Hynix [H5AN8G8NAFR](#) 8 Gb DDR4 SDRAM (16 GB total)
 - AMD Radeon Pro 555X GPU
 - 4x Micron [MT51J256M32HF-70:B](#) 8 Gb GDDR5 RAM (4 GB total)
 - Apple T2 APL1027 339S00533 coprocessor, layered over 1 GB Micron D9VLN LPDDR4 memory
 - Toshiba TSB3226AW8815TWNA1 and TSB3226XZ2939TWNA1 flash storage (256 GB total)
 - Intel [JHL7540](#) Thunderbolt 3 controller

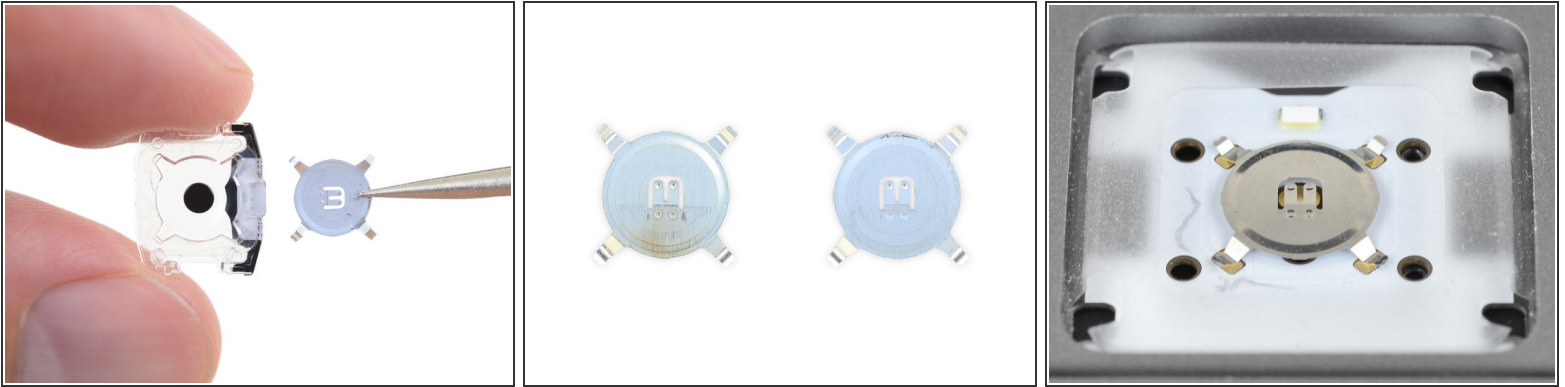
Step 8

- What else changed? We think the metal dome switch may have. Let's look closer.
 - The dome is like a really tiny [jam lid](#) or [Snapple cap](#)—you press down and it springs back up.

- If anything changes about the dome—if it's cracked or deformed—the key may behave erratically. Likewise, if the prongs break or bend, the key stops working.

- ⓘ There are myriad possible reasons for this switch to crack or wear out—manufacturing defects, plain old fatigue, prolonged heat, moisture, outgassing from other components, and corrosion are all common culprits.

- 🔧 These switches are also magnetized from the factory. Best guess as to their composition: ferritic stainless steel, with a thin polymer coating on the bottom. The difference in surface finish from the 2018 version (left) to the 2019 (right) indicates Apple may be using a revised heat treatment, or alloy, or possibly both.

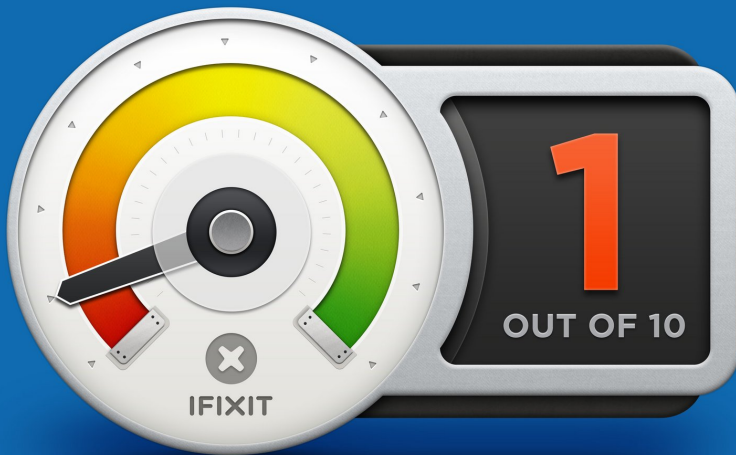
REPAIRABILITY SCORE:

- The 2019 MacBook Pro 15" with Touch Bar earns a **1 out of 10** on our repairability scale (10 is easiest to repair):
 - The trackpad can be removed and replaced with very little drama.
 - The processor, RAM, and flash memory are soldered to the logic board. Repairs and upgrades will be impractical at best.
 - The top case assembly, including the keyboard, battery, speakers, *and* Touch Bar, is glued together—making all those components impractical to replace separately.
 - The Touch ID sensor doubles as the power switch, and is paired with the T2 chip on the logic board. Fixing a broken power switch may require help from Apple, or a new logic board.
