PlayStation VR Rear LED Tracker Board Replacement

Written By: Aaron Suttles

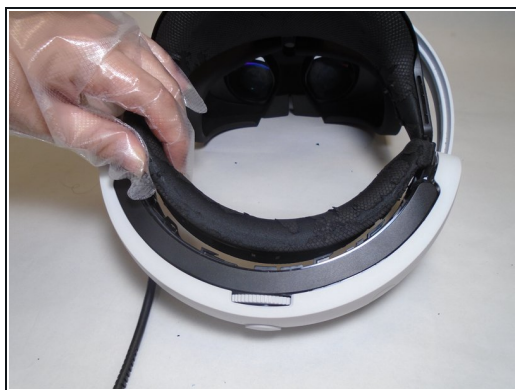
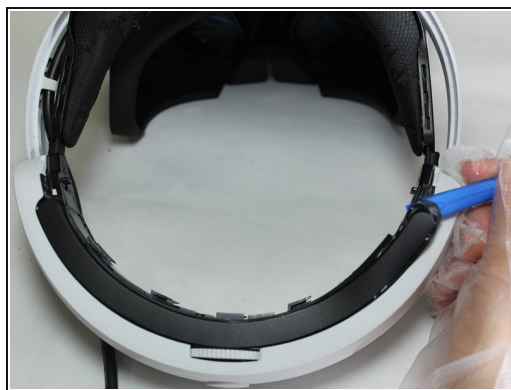
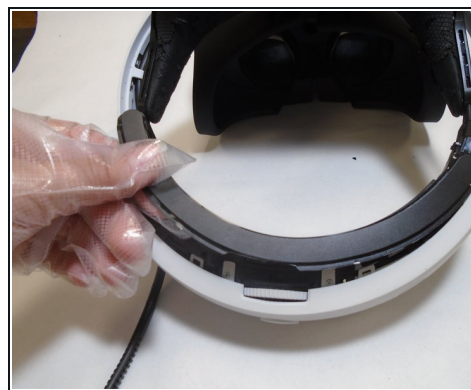
Step 1 — Band Adjuster

- Use your hands to remove the foam piece in the headband.
- Use the iFixit Opening Tool to pry the top and bottom trim pieces off of the rear band assembly.

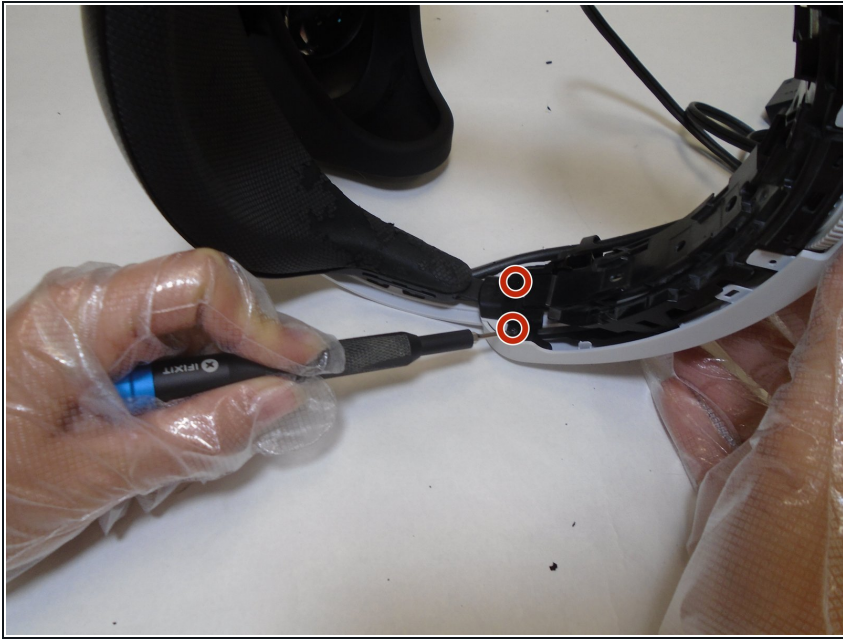
Step 2

- Remove a total of four 5 mm screws from inside the left and right sides of the headband using a Phillips #00 screwdriver.

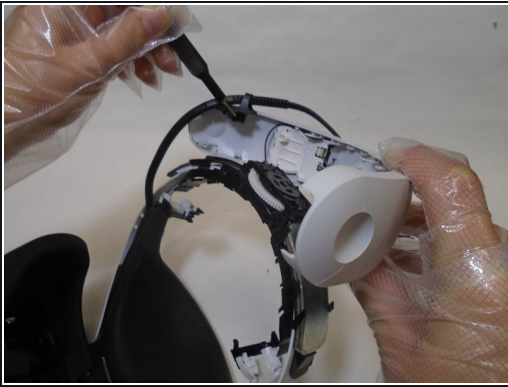
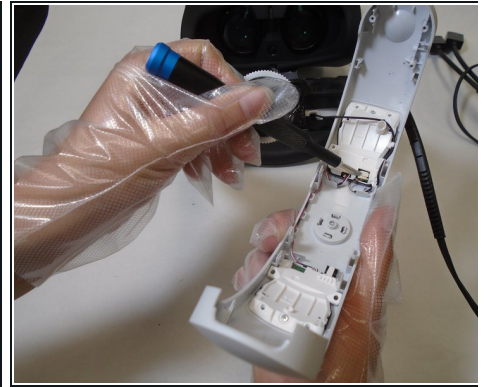
Step 4

- Remove the 6 mm screw from the retainer securing wires to the rear band assembly using a Phillips #00 screwdriver.
- Use a spudger to flip up the retaining flap connected to the rear LEDs.

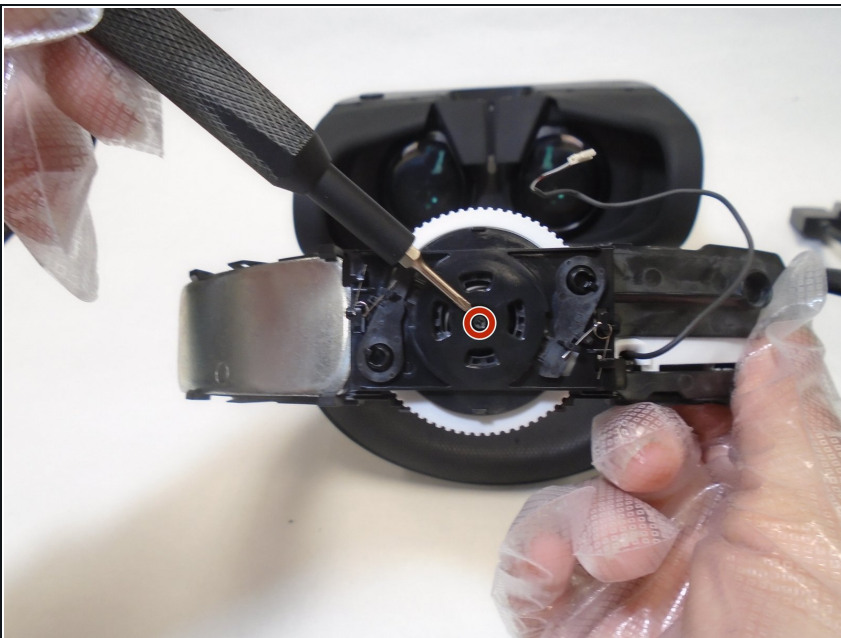
Step 5

- Remove the single 5 mm screw from the center of the headband adjuster using a Phillips #00 screwdriver.

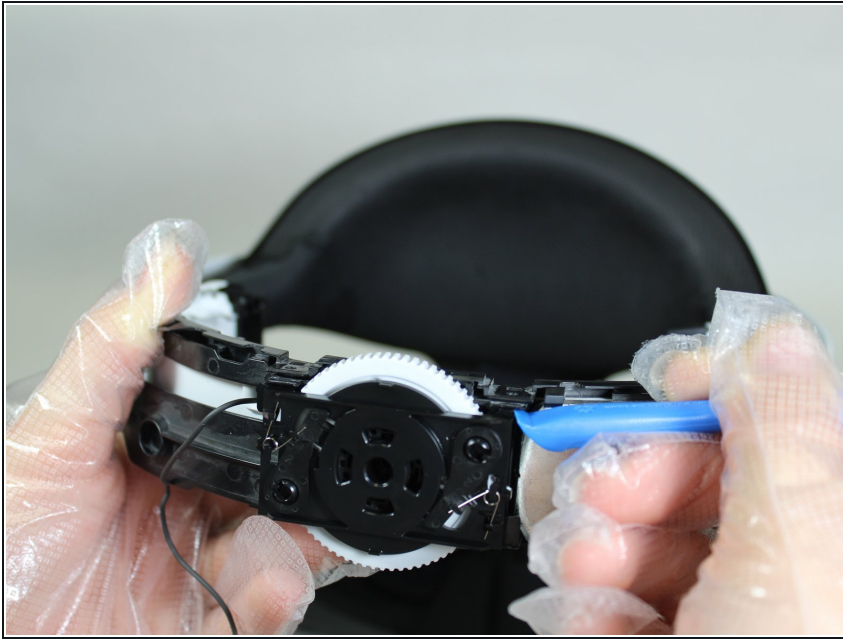
Step 6

- Gently pry the adjuster assembly away from the rear headband using an opening tool.

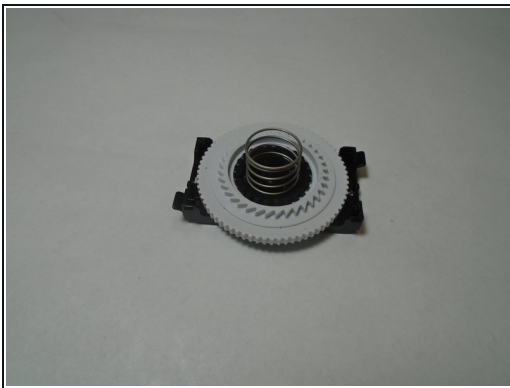
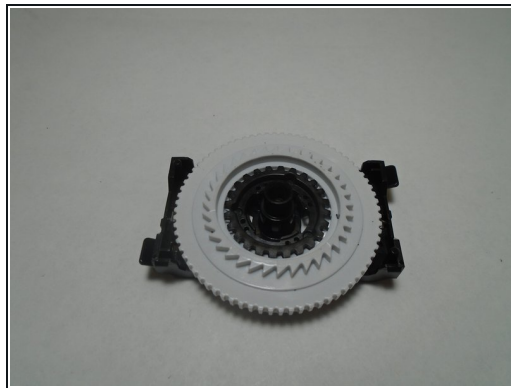
Step 7

- Disassemble the adjuster assembly spring, small gear, large gear, and bracket in order to replace the broken component.
