# Rapoo E6700 Bluetooth Touch Keyboard Teardown

This 'guide' shows that it is NOT possible to repair a damaged USB connector on this device.

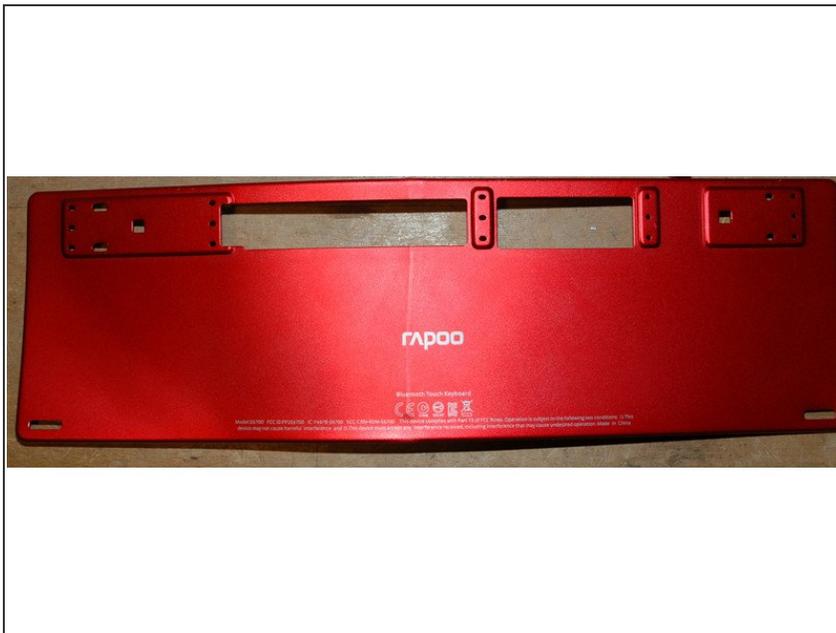
## Step 2

- I tried to get access to the damaged USB connector, but the bottom cover that contains the main PCB is held in place by screws not from the outside but the inside.
- So I broke off the bottom cover to repair the connector, but then you cannot connect back the flex connectors to the keyboard.
- Maby we can separate the keyboard from the aluminium housing ?

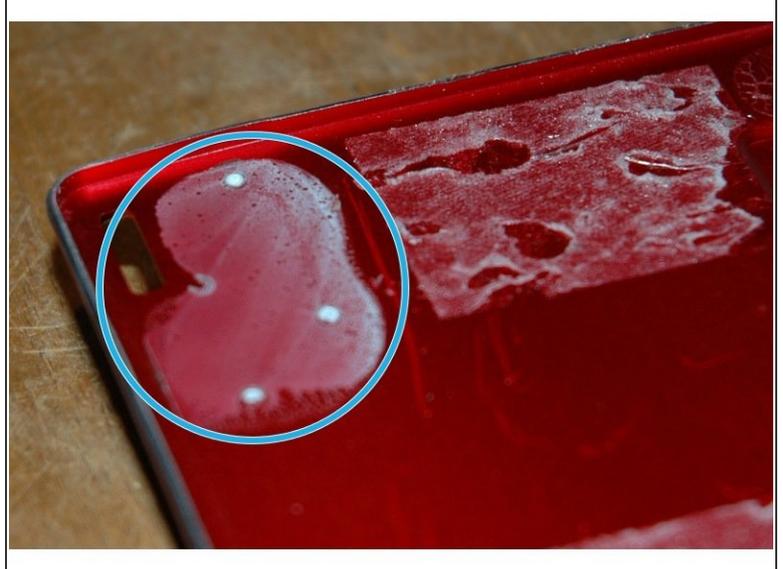
### Step 3

- Well for those who try to get the keyboard off, someone has developed superglue.
- Yes you heard it, not just sticky double sided tape, also superglue applied in the marked areas.

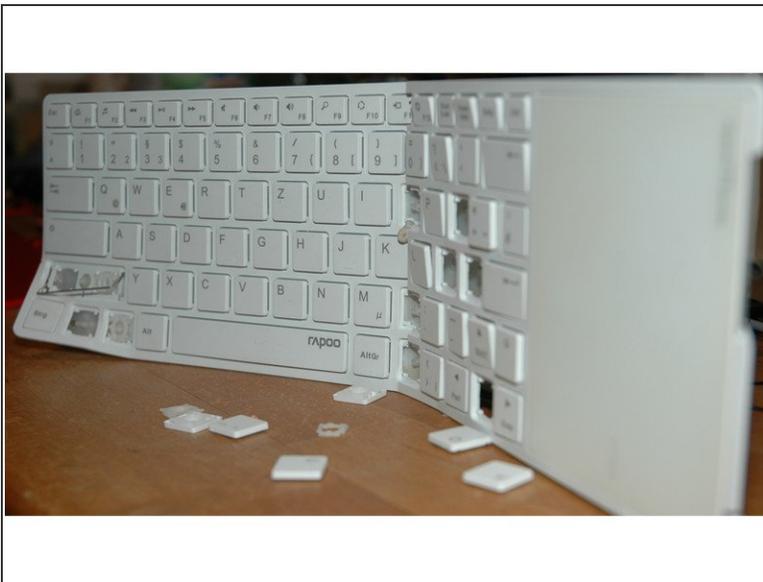
### Step 4

- Here's the keyboard after 1 hour trying to separate the parts.
- And another view of the superglue residuals on the keyboard side.

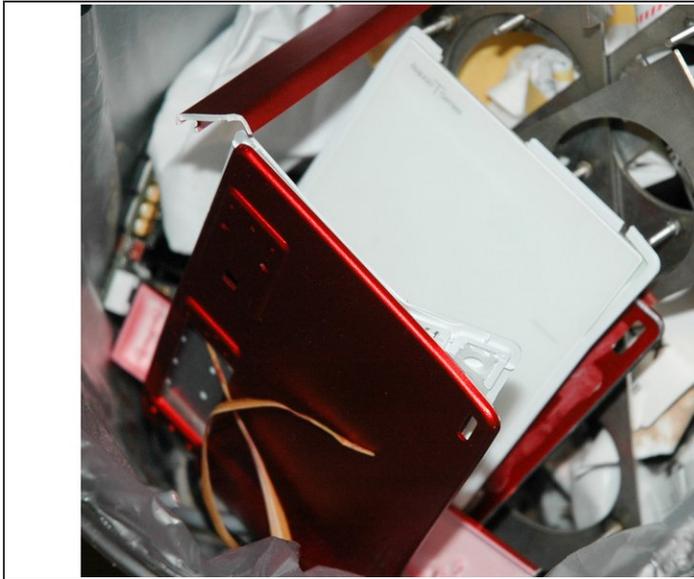
## Step 5

- This is the '**repaired**' keyboard
- and the only reason to repair: the broken off (badly soldered) USB connector.
- What a waste of materials

To reassemble your device, buy a new one
