Insignia NS-24ER310NA17 Infrared Sensor Replacement

Use this guide to replace the infrared sensor...

Use this guide to replace the infrared sensor in your Insignia NS-24ER310NA17 television.

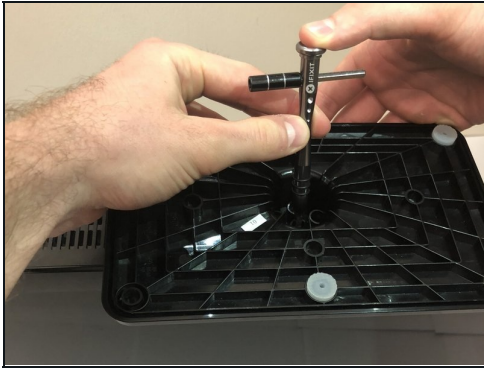
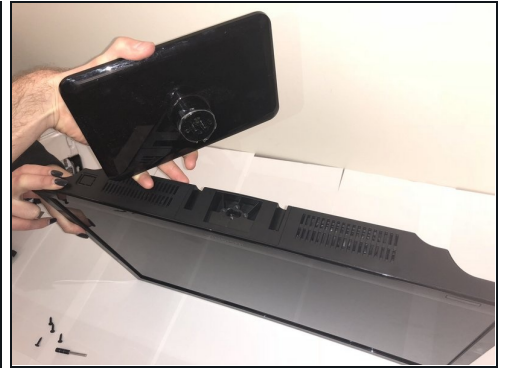
Step 1 — Remove the base

- Rest the TV on its top edge so you have access to the base.
- Use a Phillips #2 screwdriver to take out the four screws on the bottom of the base.
- Remove the base from the frame.

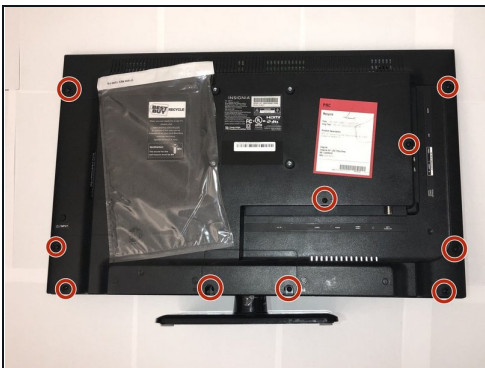
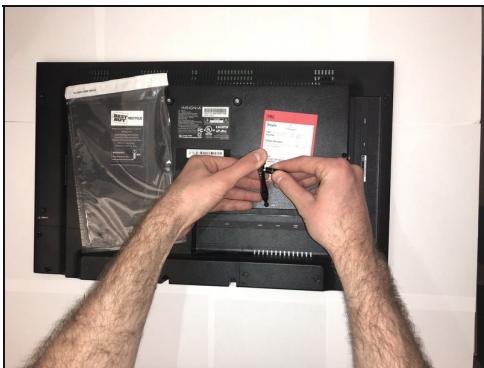
Step 2

- Lay the TV face down.
- Use the Phillips #00 screwdriver to remove all of the Phillips Head Screws from the the back of the TV.

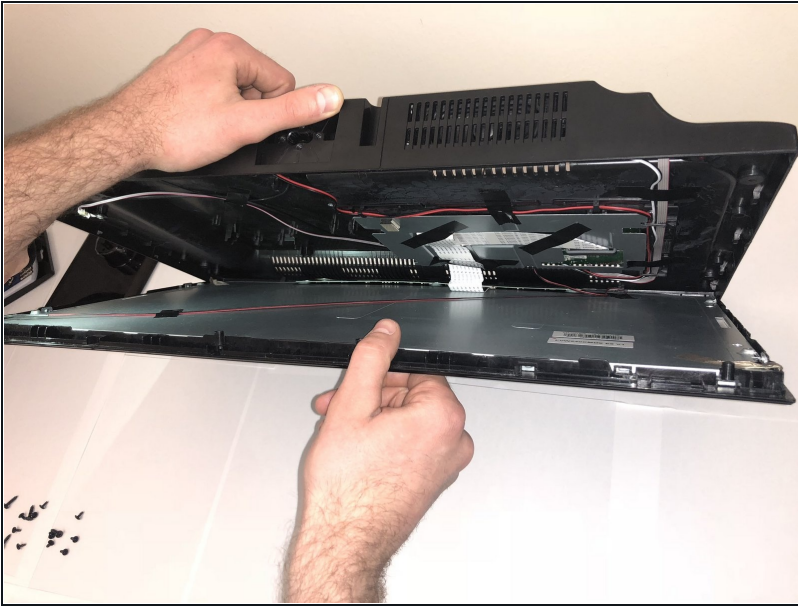
Step 3 — Pry the TV open

- Stand the TV on its top edge.
- Gently pry apart the front and back of the TV.

① The two halves should pull apart easily since there are no longer any screws holding it together.

⚠ The two halves will still be connected by wires and cables that are taped to each side. Do not pull on these. We will remove them in the next step.

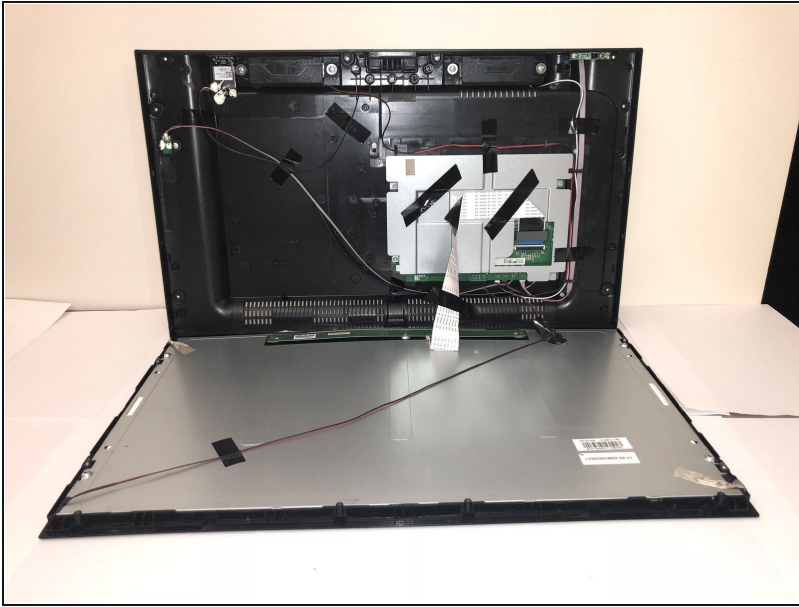
Step 5

- Spread apart your TV the rest of the way, but do not disconnect any of the wires.
- ① You should have a clear view of the inside on both sides.
