How to Get Rid of Fan Clicking Noises on a Toshiba TDP-XP2

Written By: Bryan Underwood

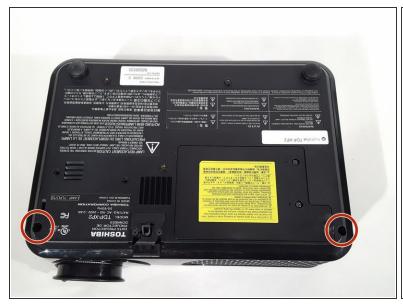
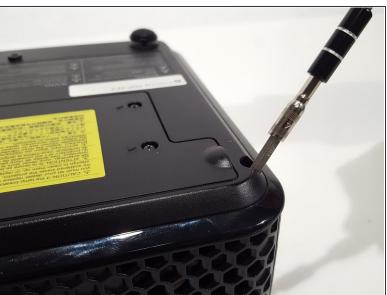
Step 1 — How to Get Rid of Fan Clicking Noises on a Toshiba TDP-XP2

Start by removing the two screws on the bottom of the device as shown.

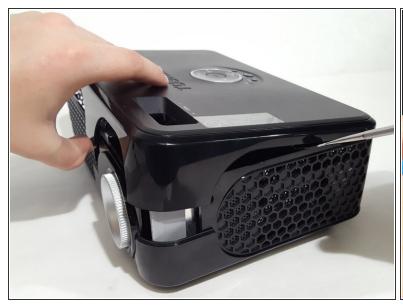
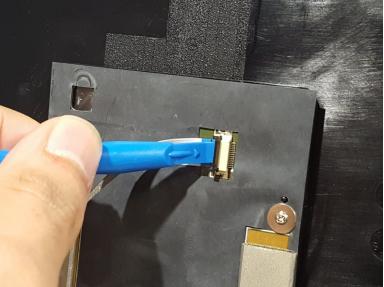
Step 2

- Remove the top plastic cover from the device. The back is snapped on so it would help to have leverage from a prying tool.
- Remove the ribbon cable attached to the plastic piece just removed. Remember its orientation for re-assembling later.

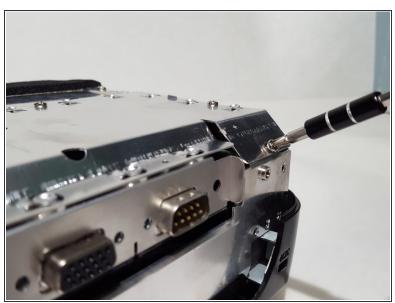
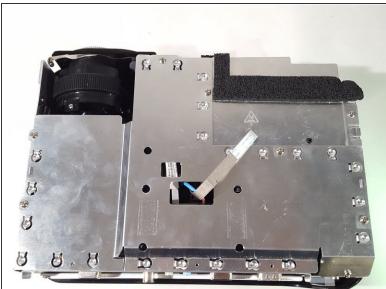
Step 3

Unscrew the screws from the metal shielding to remove it.

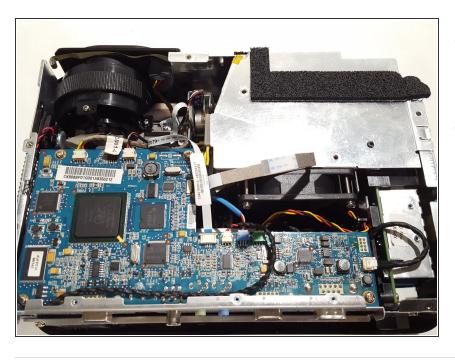
Step 4

- Move any wires out of the way of the fan so they won't grind up on it during operation.
- If the cables do not stay out of the way, tape them down away from the fan.

To reassemble your device, follow these instructions in reverse order.
