# Lenovo ThinkPad S431 Integrated Camera Replacement

This guide will show you the steps to safely...

Written By: Mohammed AlManai

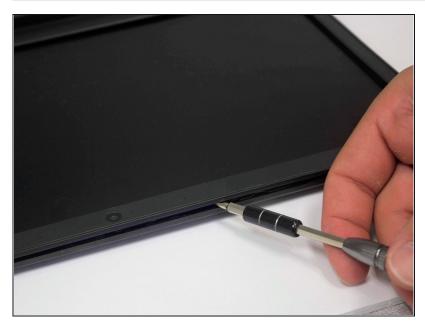
#### **Step 1 — Screen Assembly**

- Place an opening tool under the screen cover, and pop it off.
- ⚠ Using a metal object to open fragile parts of your laptop could cause damage! Instead use the opening tool listed in the tools section above.

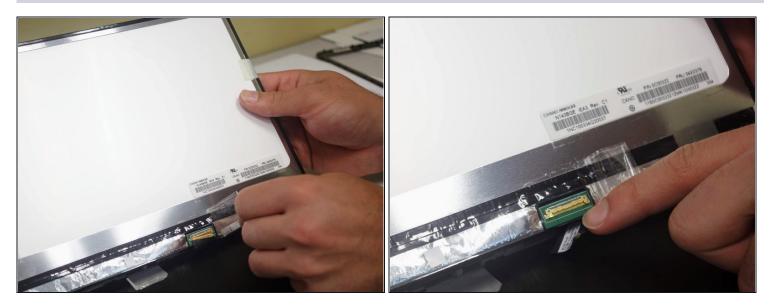
### Step 4

• Remove the connector located at the bottom of the back of the screen.
