INTRODUCTION

In this guide the repairer replaces the microphone by disassembling the device to access the motherboard.

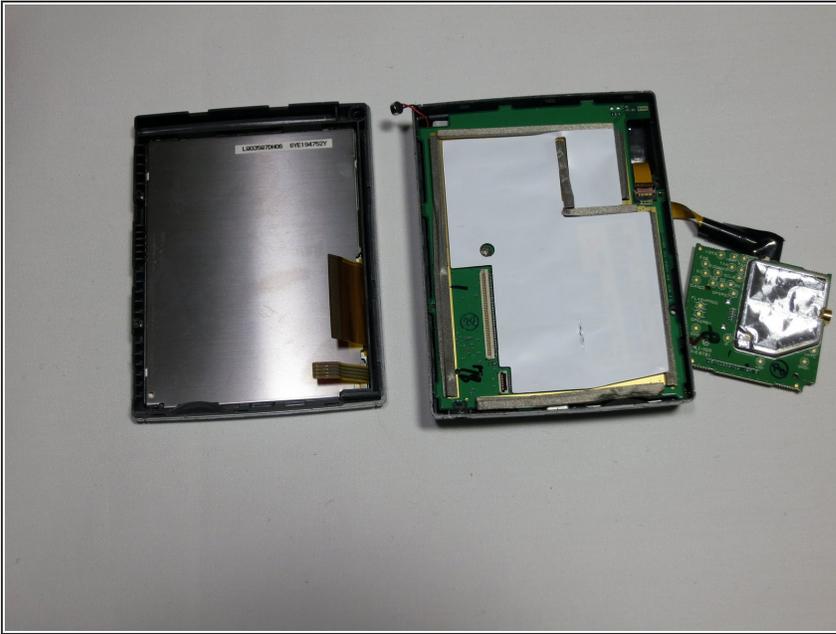
Step 1 — Microphone

- After following the instructions in the [main dis-assembly guide](#), you should have the screen detached from the motherboard.

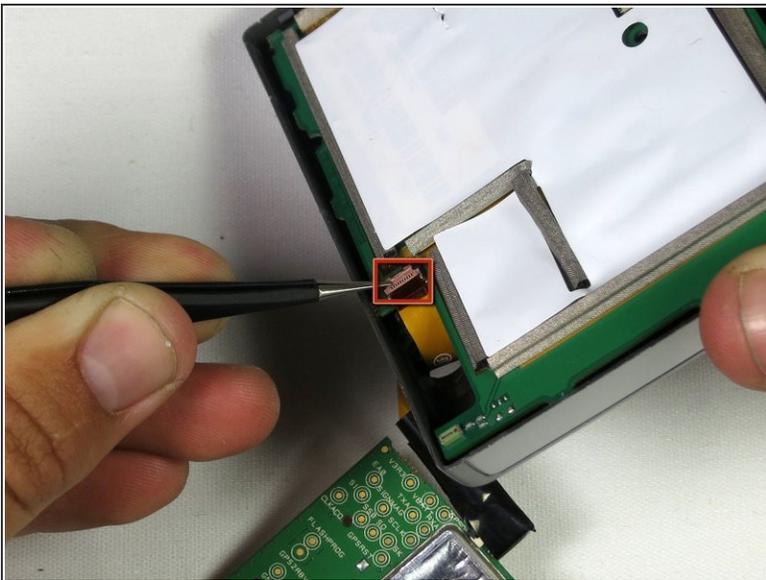
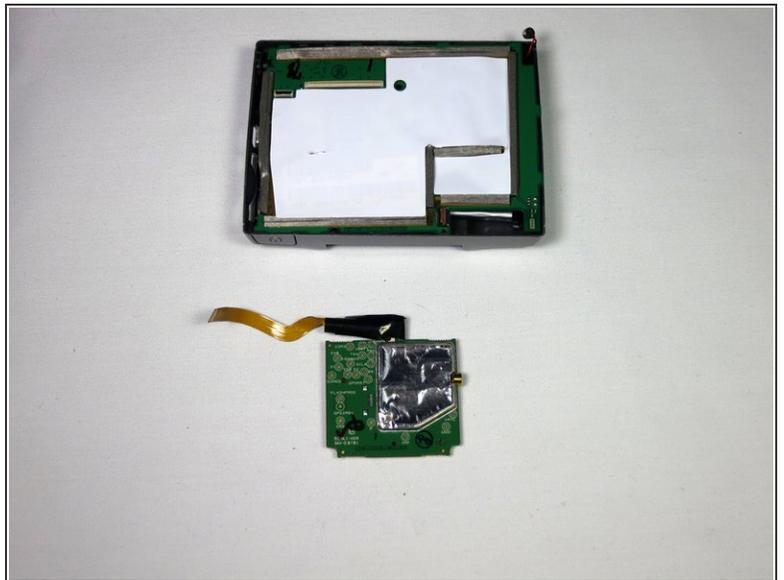
Step 2

- Use the tweezers or the spudger to lift the tan latch off the ribbon cable (ZIF connector) and gently pull out the ZIF connector and cable from underneath the opened latch.

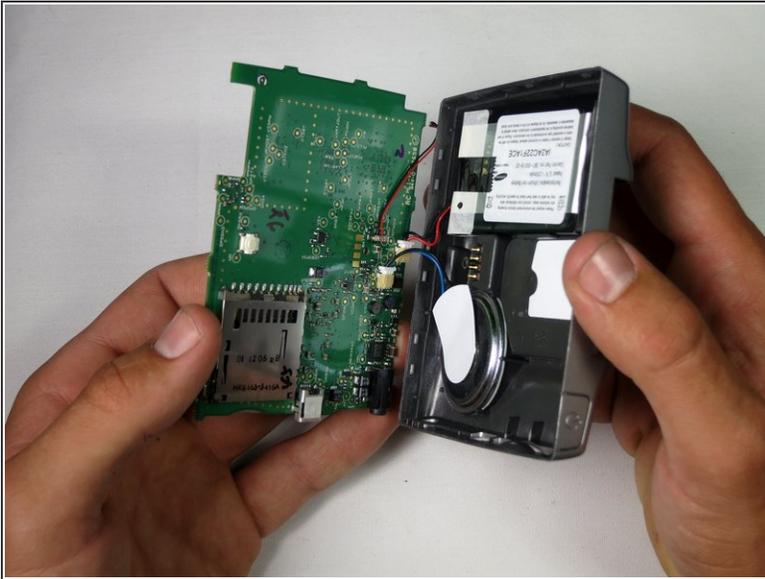
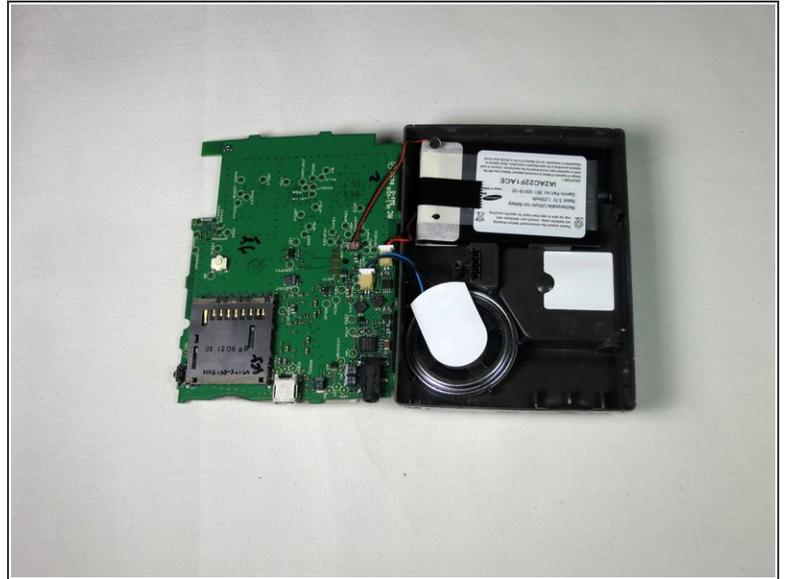
Step 3

- The motherboard will now freely separate from the back casing; lay it flat next to the housing.

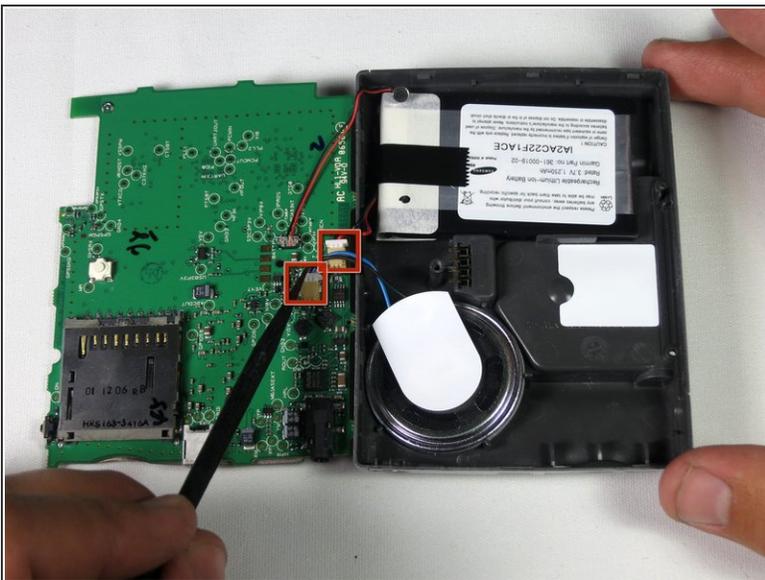
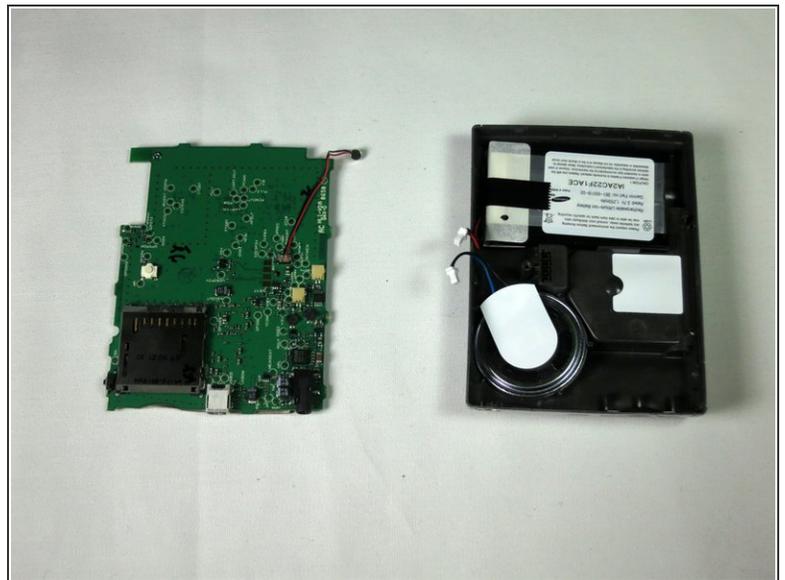
Step 4

- Disconnect the speaker and battery from their terminals on the motherboard. This should disconnect the motherboard completely from the back panel.
- ⓘ This step is optional but is recommended as it will create more room to work.
- ✦ It is recommended that you use tweezers or the spudger for precision.

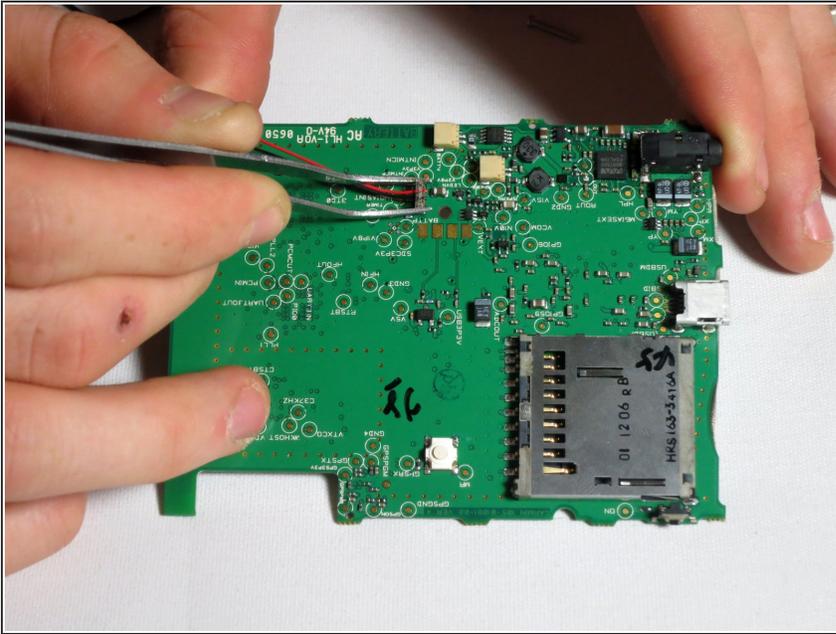
Step 5

- Gently pull out the microphone wire from the terminal. Tweezers are recommended for precision.

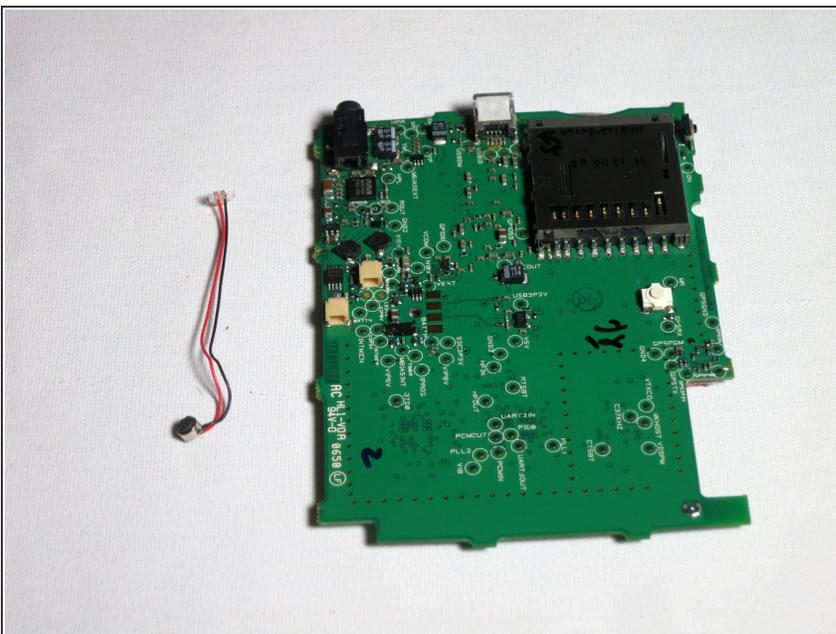
Step 6

- The microphone component should now be completely separated from the motherboard.
- Plug in new, functional microphone component.
