# Xbox 360 Top Vent Replacement

Top vent replacement.

Use this guide to remove the gray plastic top vent from your Xbox 360.

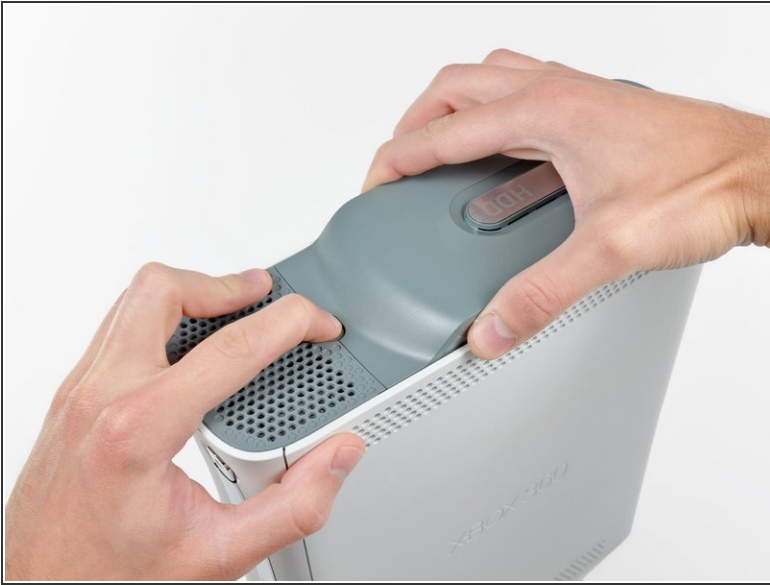
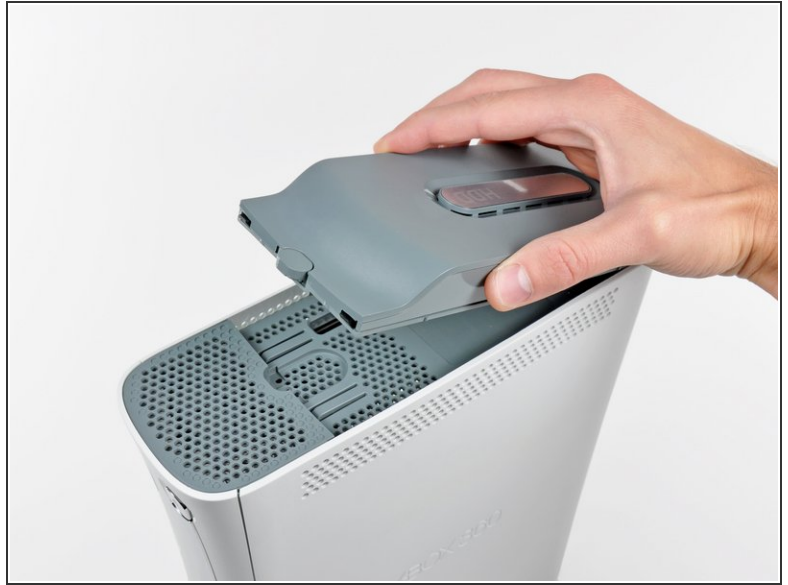
## Step 1 — Hard Drive

- Grasp the hard drive assembly and press the release button while lifting its front edge.
- Remove the hard drive assembly from the top vent.

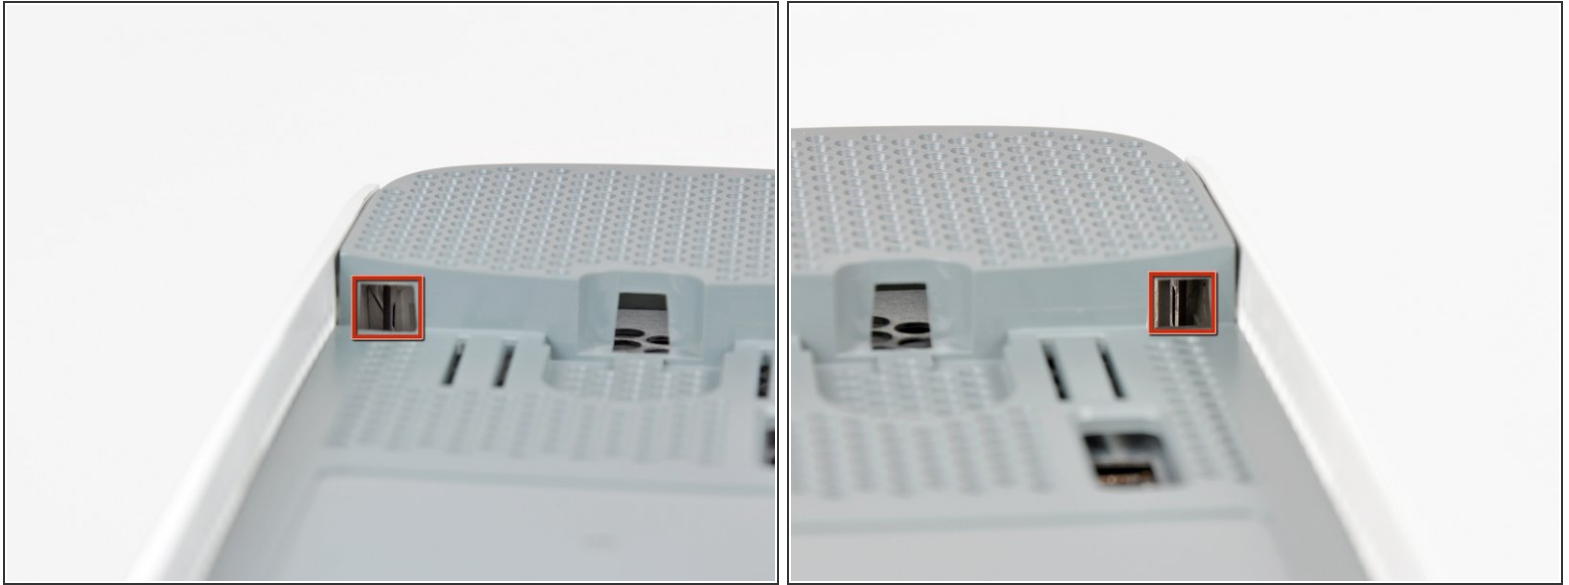
## Step 2 — Top Vent

✦ Stand the console vertically with the top edge facing up.

- The top vent is secured to the console via clips. The first two clips are located underneath the top vent closest to the faceplate, as shown in the pictures.

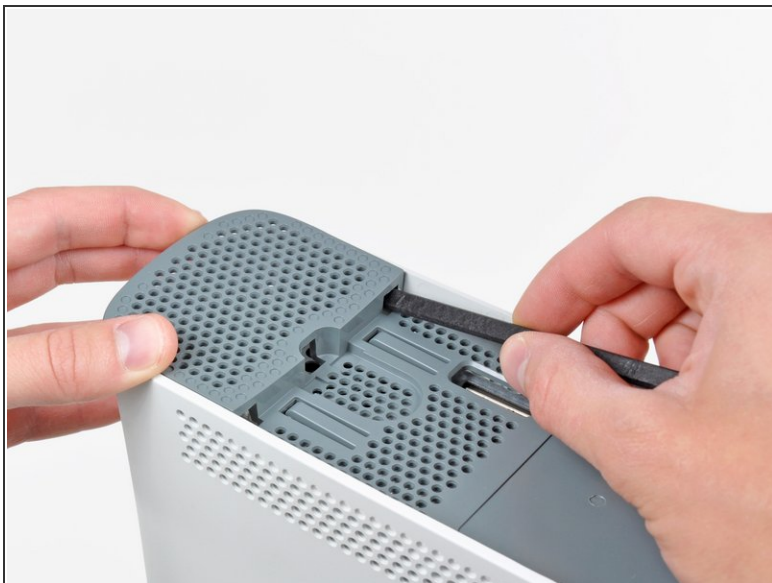
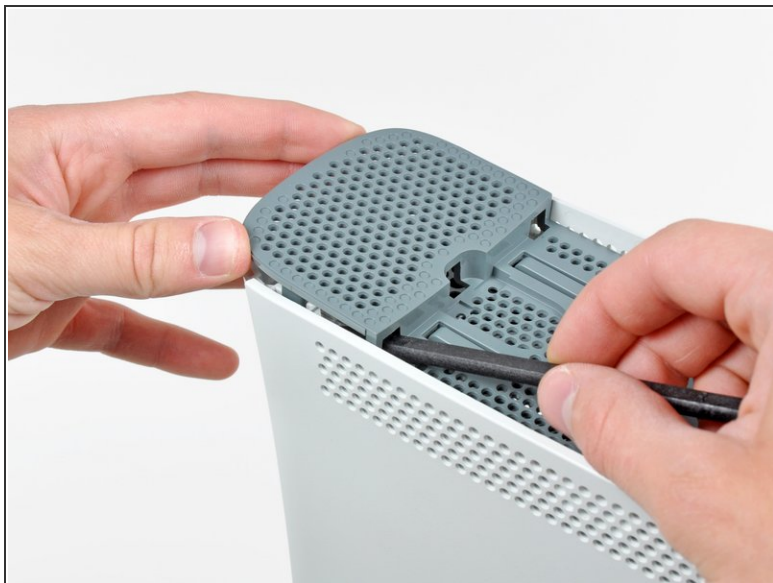
## Step 3

- Insert the flat end of a spudger into the small gaps previously mentioned to release the clips.

**i** You may also use the long finger of an Xbox 360 opening tool to accomplish this task.

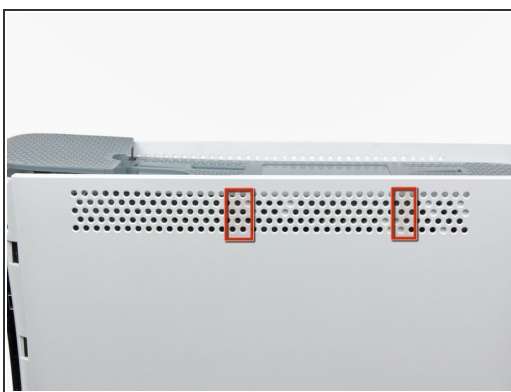
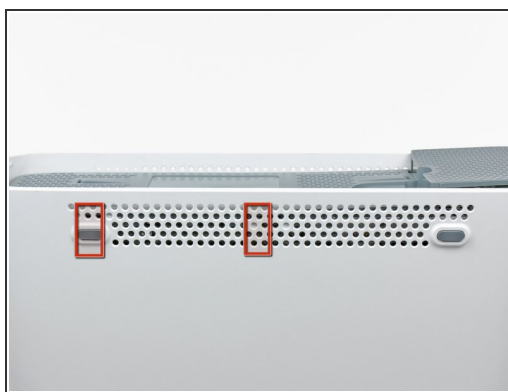
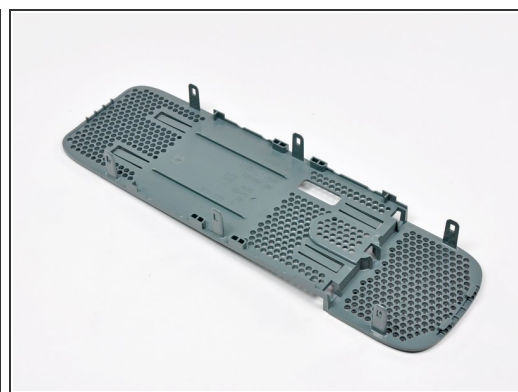
## Step 4

**i** In the next few steps, you will use the tip of a spudger or the finger of an Xbox 360 opening tool to release the clips along the left and right sides of the top vent. Their locations are highlighted in red.

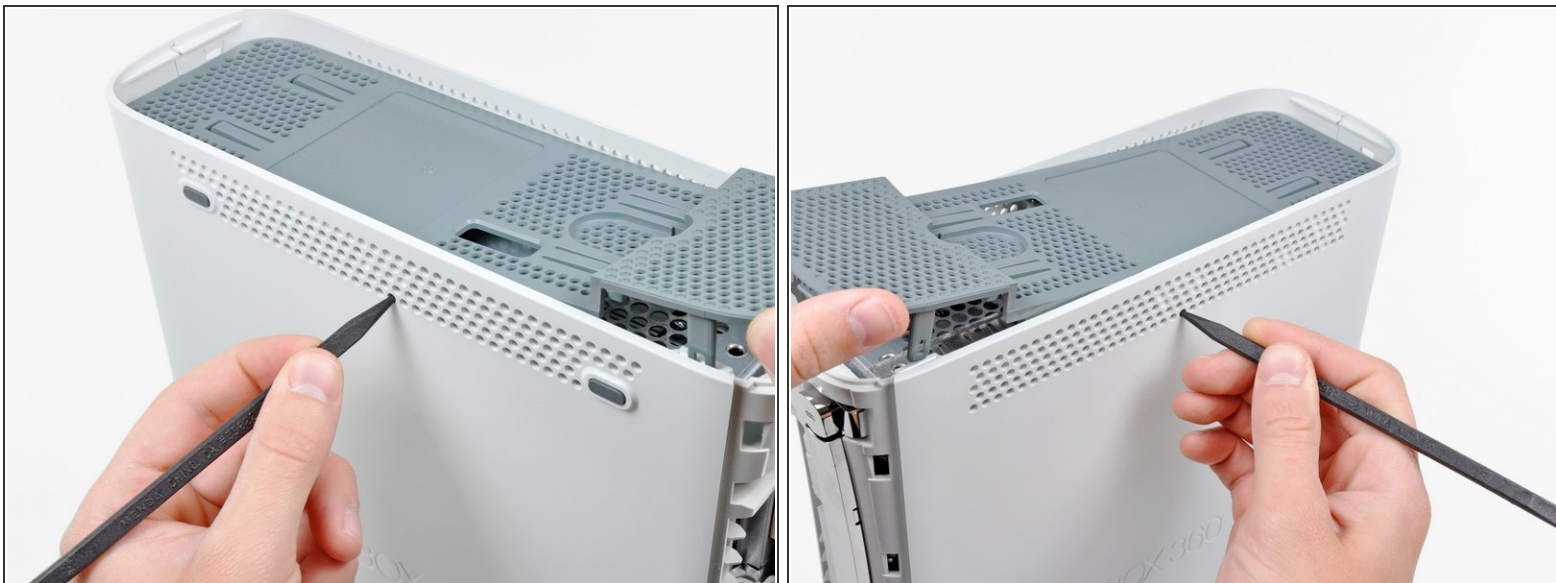
## Step 5

- To release the clips, work from the middle of the top vent.
- While slightly lifting the front edge of the top vent, use the tip of a spudger to push the clips closest to the center of the top vent towards the inside of the console.

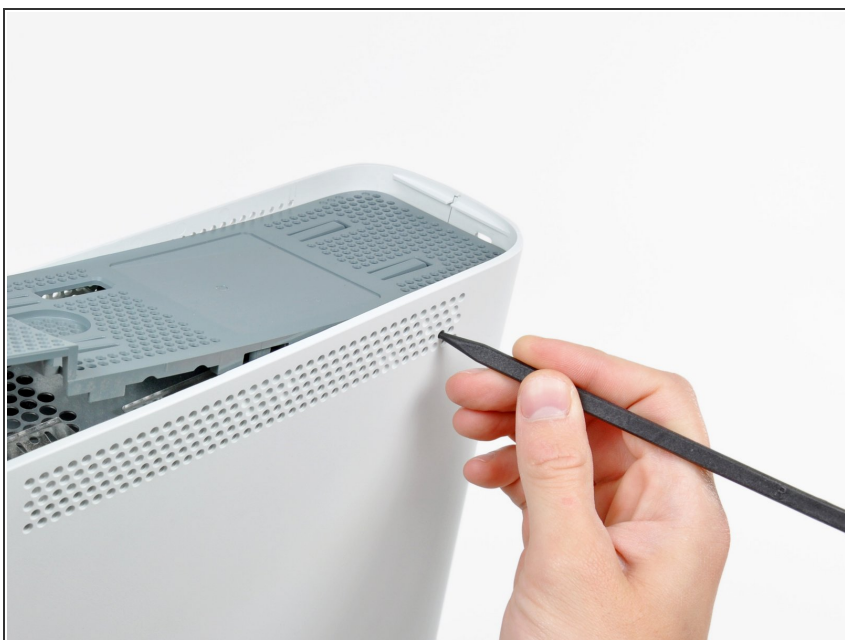
## Step 6

- Use the tip of your spudger to release the clip on the top vent nearest the back of the Xbox's upper case.

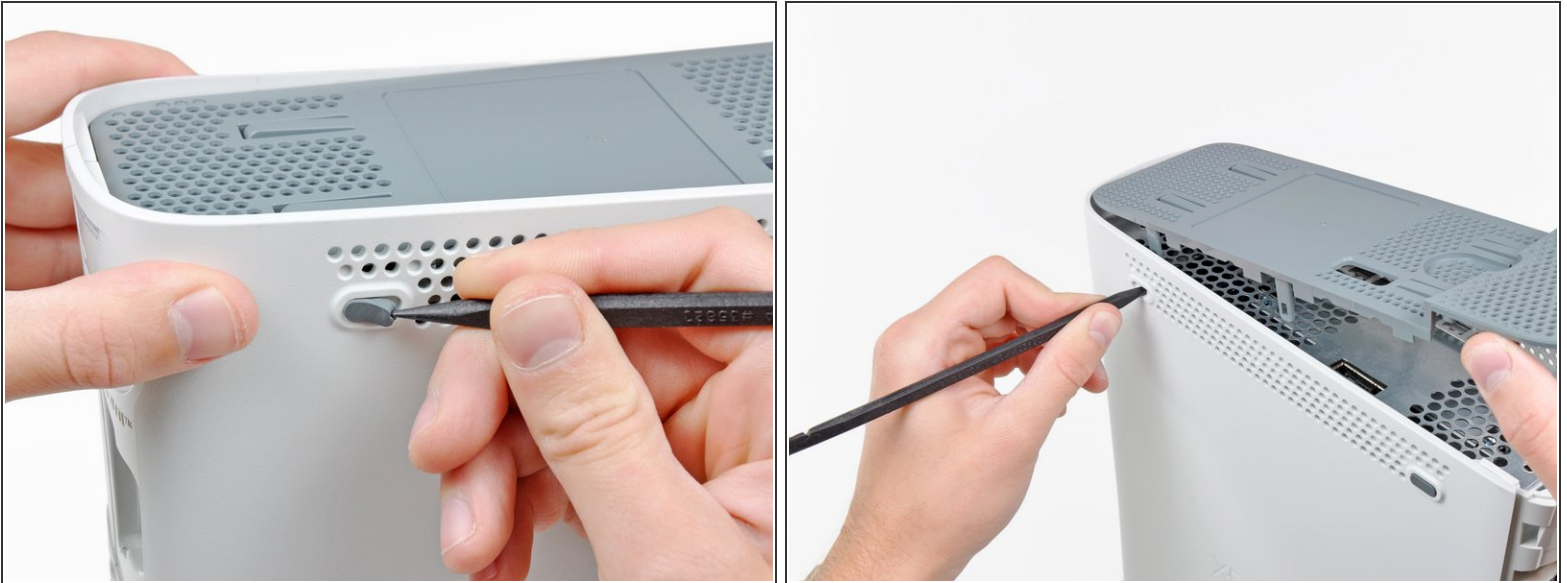
## Step 7

The last clip is hidden underneath the rubber foot nearest the back of the console.
- Use the tip of your spudger to release the clip on the top vent nearest the back of the Xbox.
  - Remove the top vent from the 360.
